Electric Shock Incident

Date / Time: 1 August 2024 - Thursday, 15:23
Location Between Barangaroo and Martin Place on the Up
Inter-Station: TS31 – Additional Emergency Exercise
Duration: 15:09 - 15:31

Summary of Incident

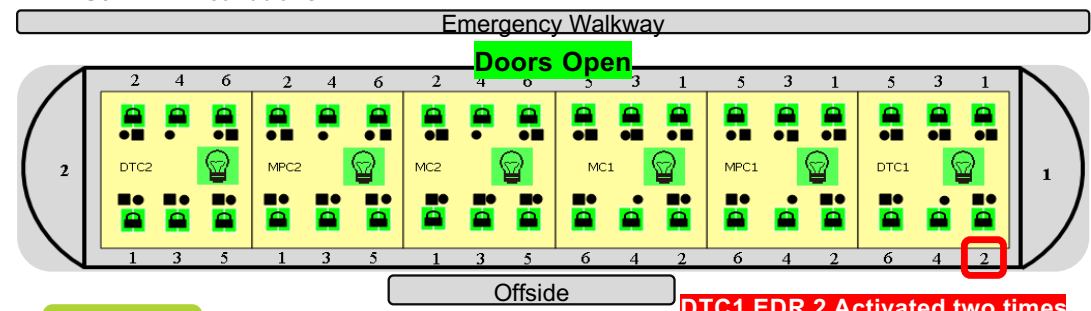
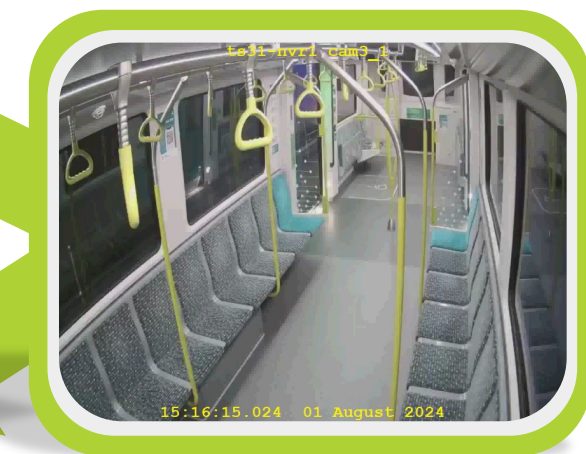
15:16

DTC1 EDR 2 Activated two times
Note 2 red lights in video

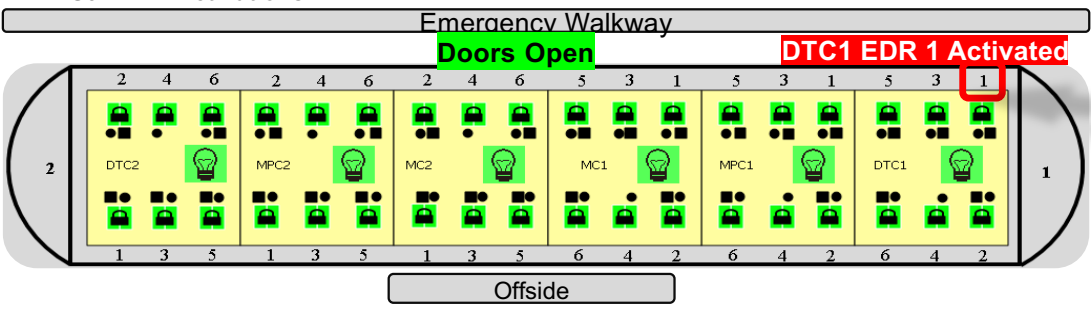
15:17

DTC1 EDR 1 Activated

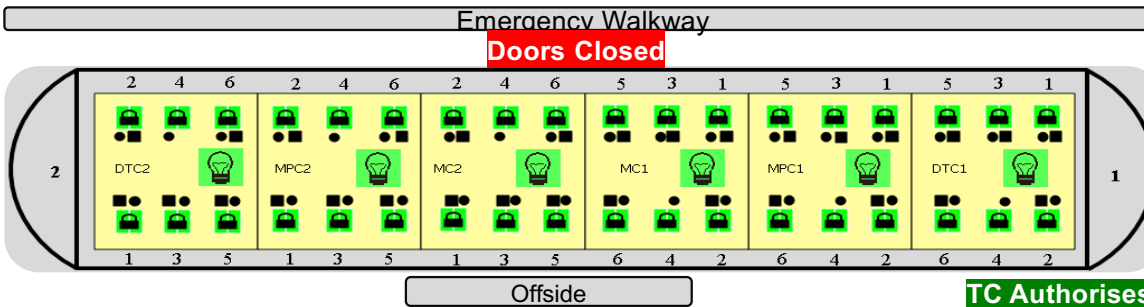
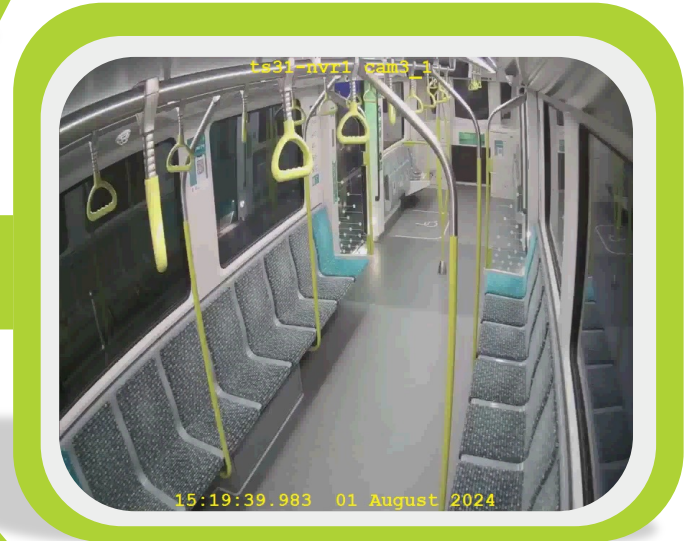
15:22

TC Authorises Doors Open

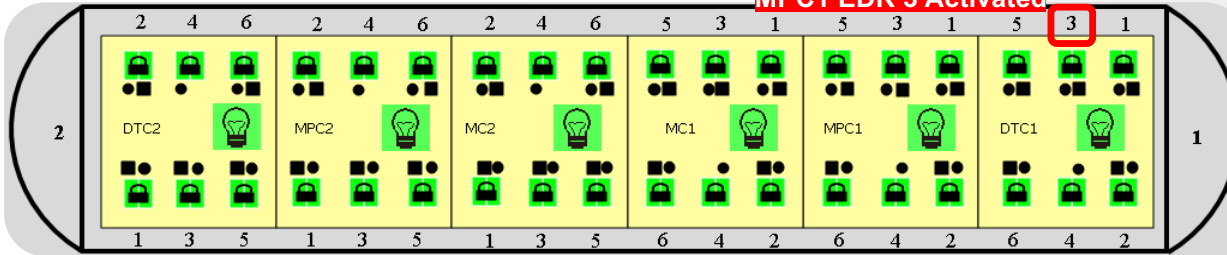
15:23	MPC1 Door 3 EDR on emergency walkway is activated again by FRNSW – “Zapp” sensation reported by FNRSW member
15:23	All doors are open via the OCC – TC remotely

MPC1 EDR 3 Activated

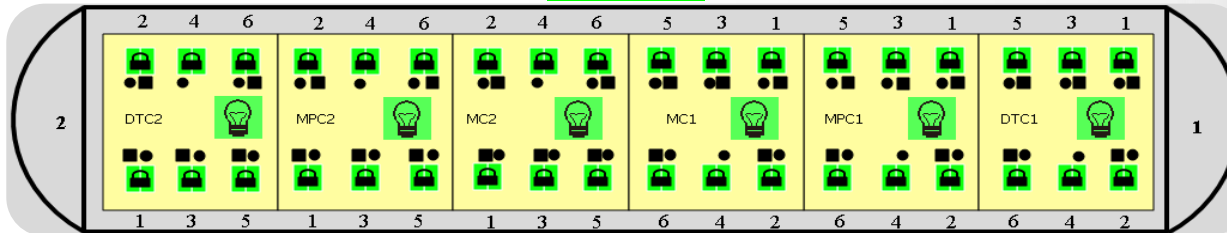
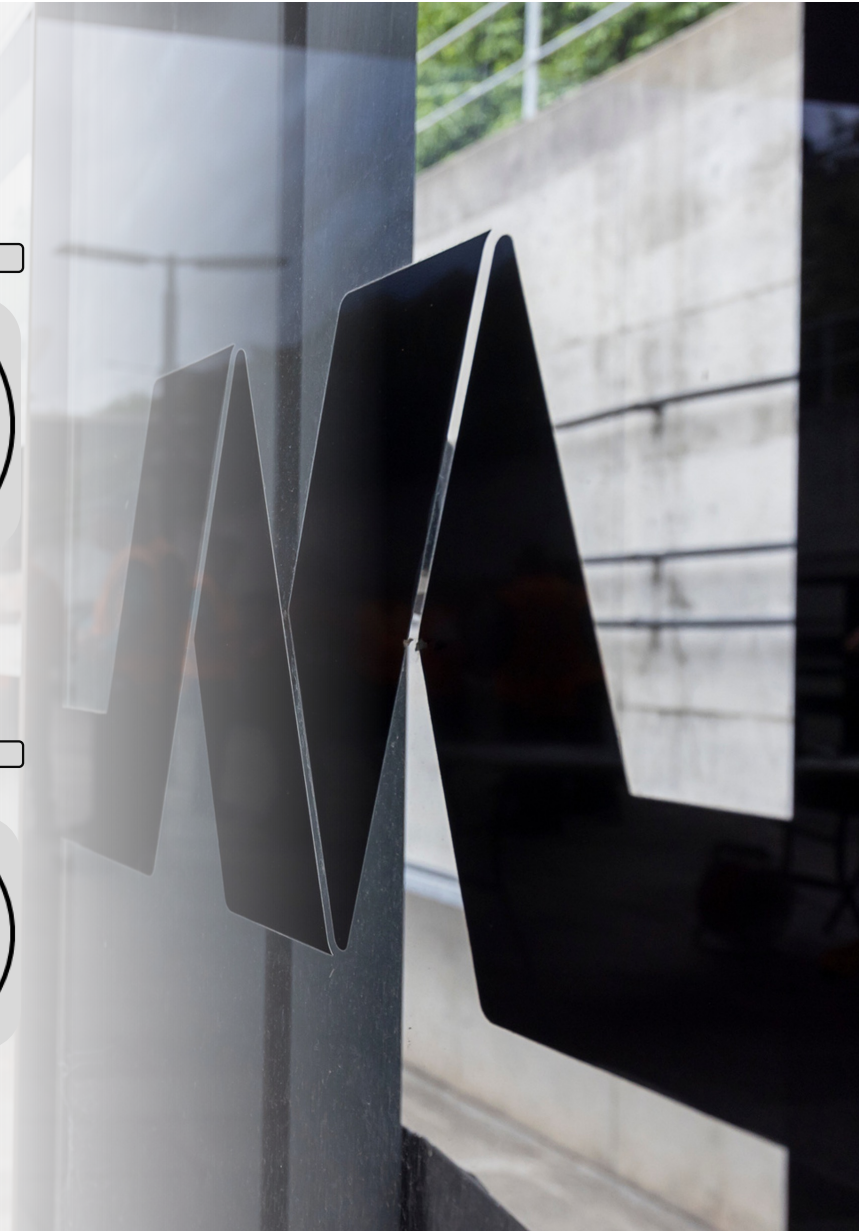
15:23

Doors Open

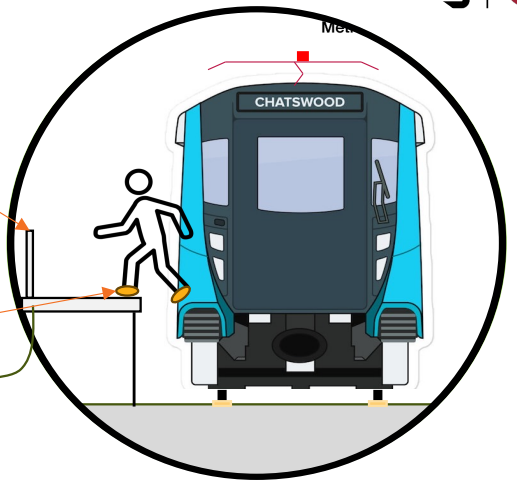
During an Evacuation passengers are directed to hold the handrail away from the train, moving them away from the touch potential points on the train.
Shoes provide enough Insulation to prevent a Rail-Earth Shock.

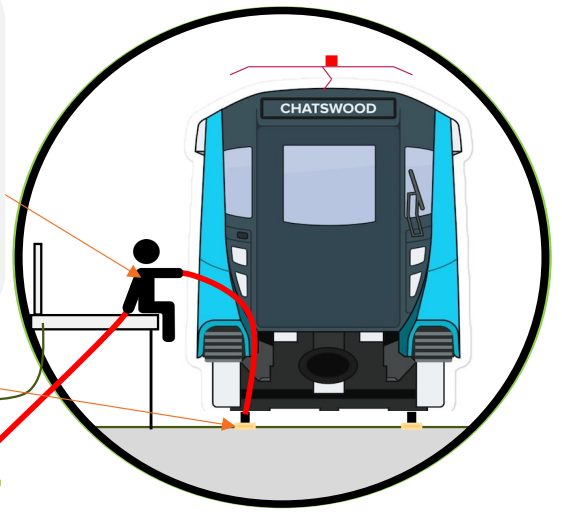
- TS31 underwent full train maintenance exam with EDRs inspected – confirmed compliant with technical maintenance standards.
- Root cause - FRNSW exercise participant making contact between Rail connected Trainset and Earth Emergency Walkway (graphic on slide 8) – therefore being subjected to Rail-Earth Touch Potential and potentially causing the “zap” feeling.

The Rail-Earth touch potential had been realised with positioning of FRNSW member, hence experiencing the zap feeling - difficult to quantify exact voltage although measured within design and EN standards.

MTS confirmed current PPE/Standard requirements are adequate to mitigate against rail-earth touch potential
