Electric Shock Incident

Date / Time: 1 August 2024 - Thursday, 15:23
Location Between Barangaroo and Martin Place on the Up
Inter-Station: TS31 – Additional Emergency Exercise
Duration: 15:09 - 15:31

Summary of Incident

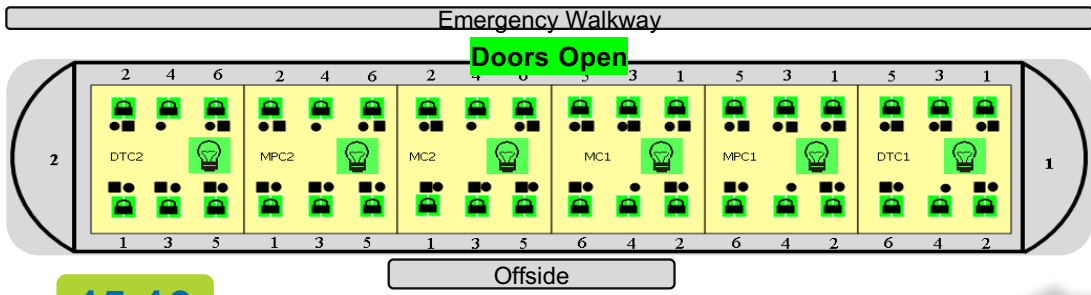
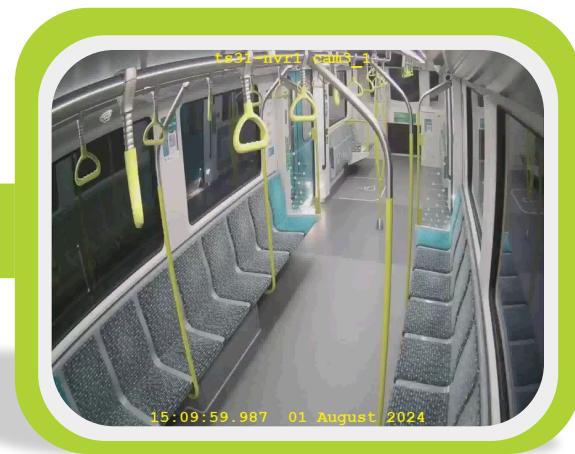
Time	Event
15:10	All doors on emergency walkway side were remotely opened by OCC as part of the evacuation exercise scenario.
15:16	DTC1 Door 2 EDR (Emergency Door Release) was activated two (2) times by FRNSW from outside the train opposite side to the emergency walkway. Door authorisation was not provided by OCC as this was not part of the agreed scenario/exercise.

TS31 EDR Activations

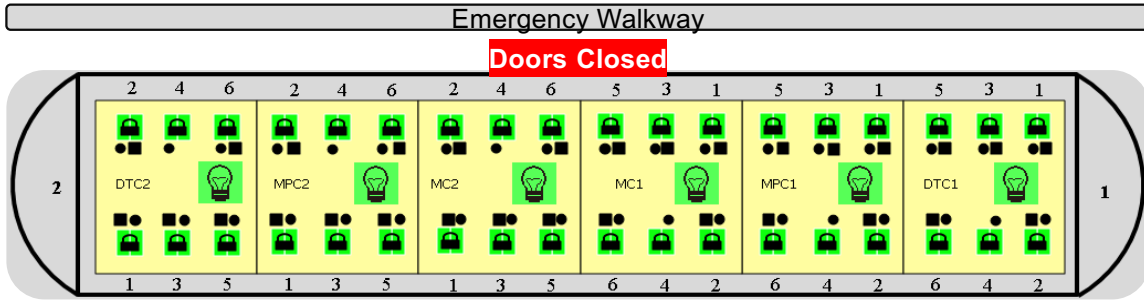
15:17	DTC1 Door 1 EDR (emergency walkway side) was activated by FRNSW while doors remained open.
15:19	All doors are automatically closed following 10-min system timeout, operating as per system design.

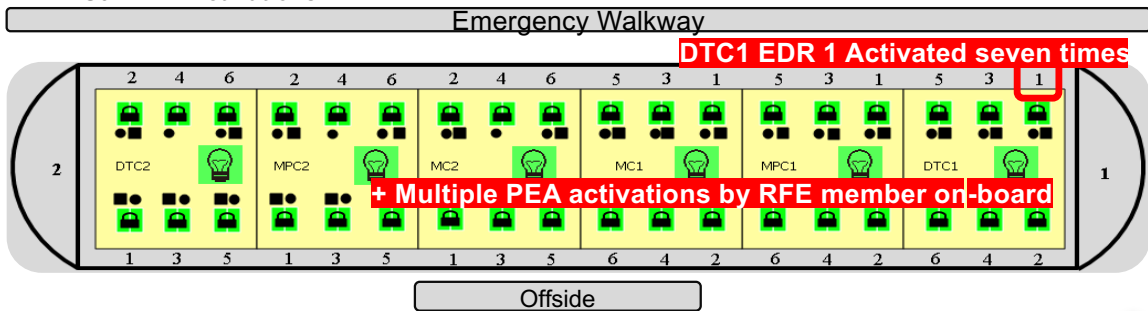
15:20	DTC1 Door 1 EDR (emergency walkway side) activated another seven (7) times by FRNSW and PEA (Passenger Emergency Alarm) activated onboard train by RFE (Rail Fire Engineering) at the same door.

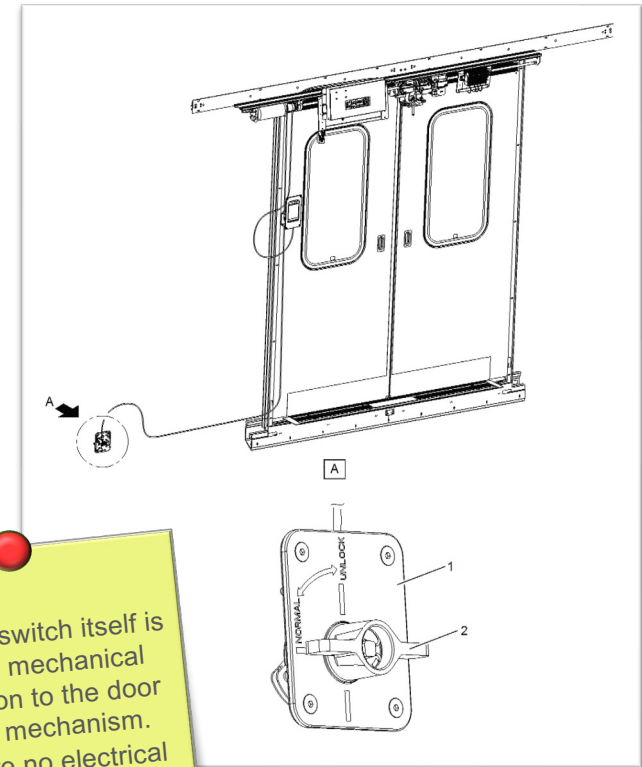
When an EDR is activated, and the trainset is localised and communicative, EDR activation requires TC authorisation to enable door open.

The EDR switch itself is purely a mechanical connection to the door release mechanism. There are no electrical components attached to the switch itself.
